The Owner's Guide to Piano Repair

Focus On: Brass Rail Repair

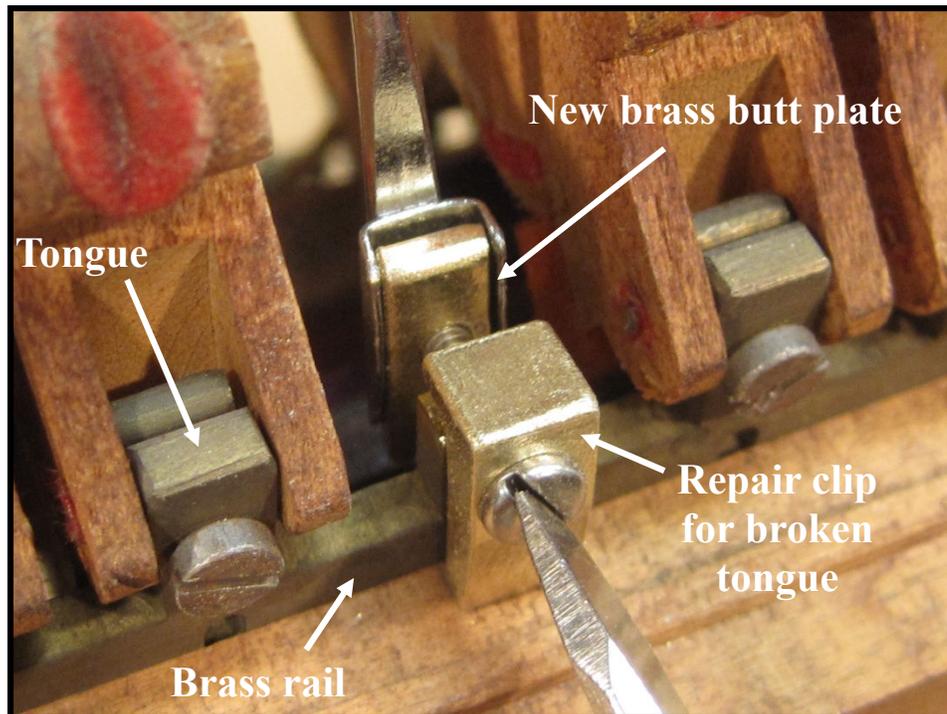
Repair being made to broken brass rail.

Unfortunately, both the tongues of the brass rail itself and the brass butt plates are eventually susceptible to metal fatigue—although it often takes a century or so for problems to develop. Breakage is most likely to occur at the screw holes drilled into the brass butt plates and the tongues alike, and also at the channel in each tongue which allows room for the center pins. When a break does occur, the corresponding hammer butt no longer is held in check and the note will quit working, making repair work necessary (see photo above).

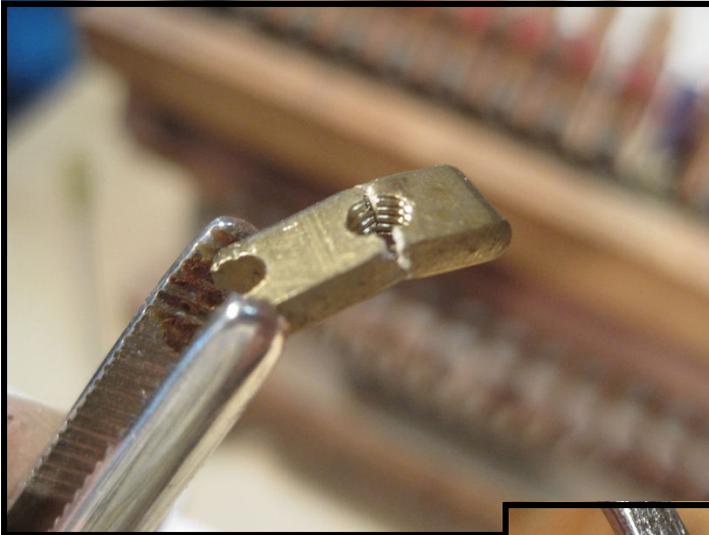
When a butt plate breaks, the break is nearly always in line with the threaded hole which is intended for a machine screw to affix the butt plate to a tongue of the brass rail. Typically, the break begins as a hairline crack (signaled by a loose or wobbly hammer assembly). When the break is complete, the hammer is no longer held in place.

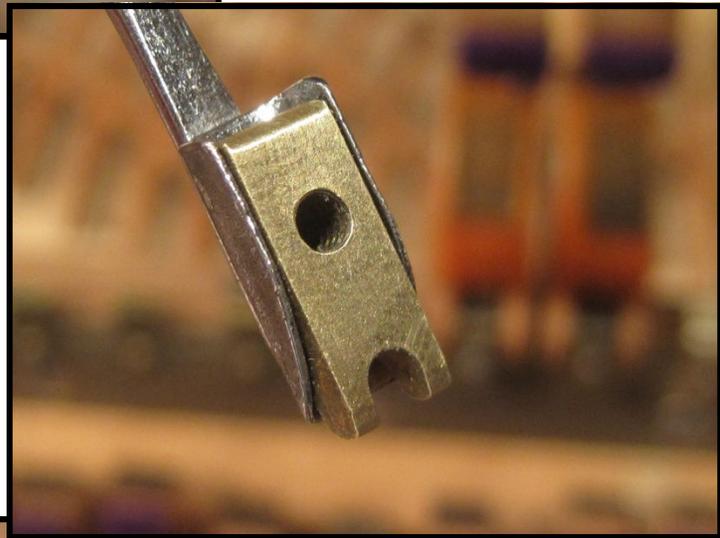
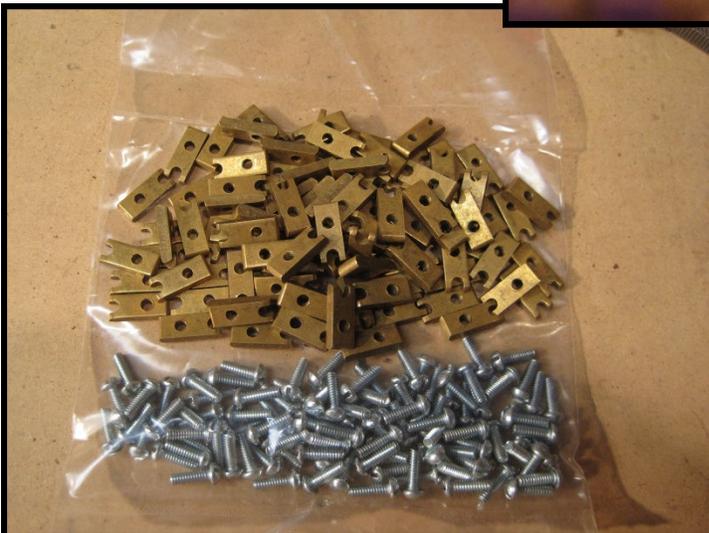
To insert a new butt plate (or plates), a special insertion tool is used to hold the small part in place while the machine screw is inserted through the tongue and into the plate. (Note: The action must be removed so that the replacement may be done from the back side of the action).

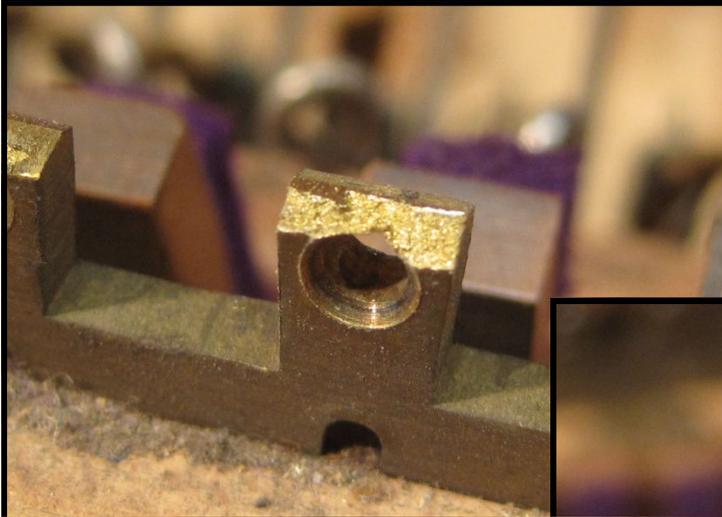
In the photo to the left, the bottom half of the channel (facing away from the camera) is still intact. The brass repair clip shown in the photos below will be used to make the tongue functional once again.

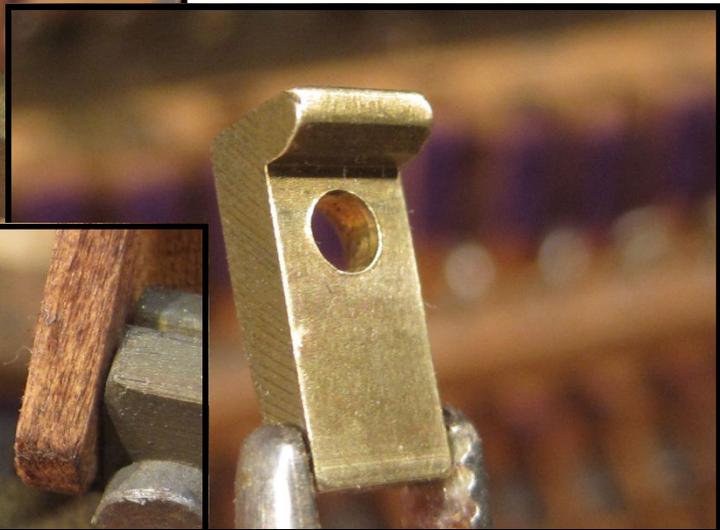
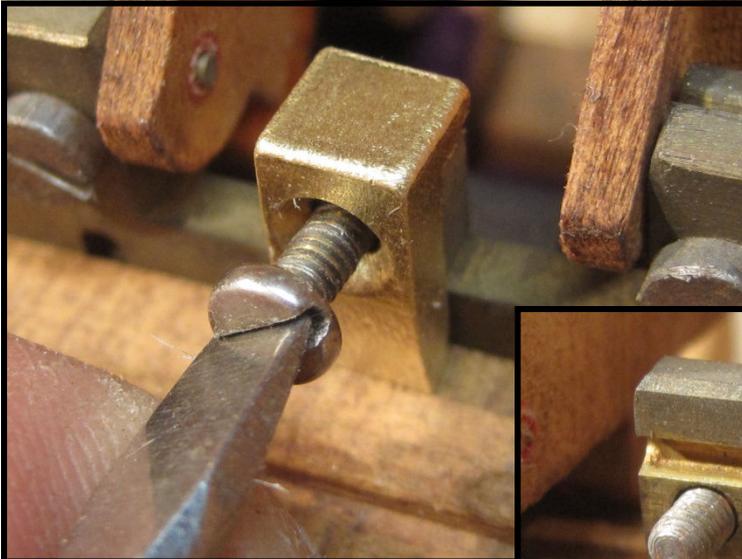
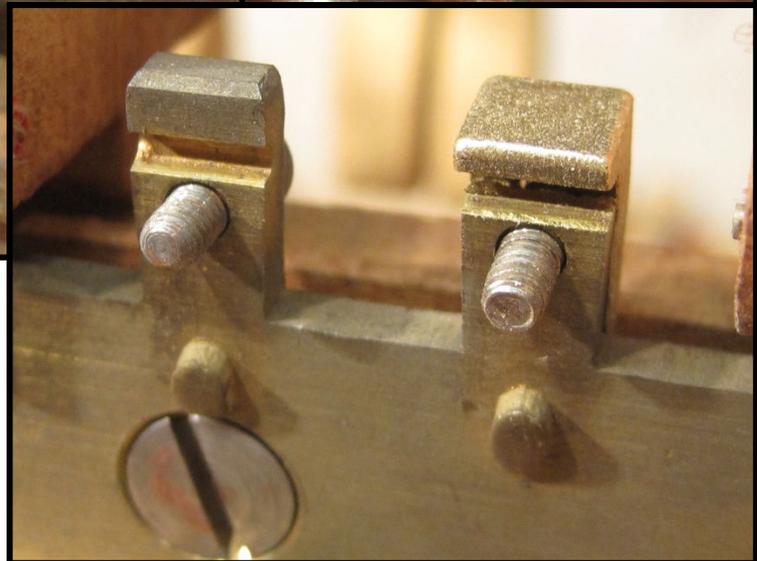
When the screw is pushed through the clip and the remaining portion of the tongue (above photo), the profile on the opposite side matches an unbroken tongue (right photo). Each screw will be driven into a brass butt plate. Before the plate is tightened down, the center pin of the corresponding hammer butt will be slipped into place in the channel provided. **Note: If a number of tongues are broken, a more appropriate repair might be the duplication and replacement of the**

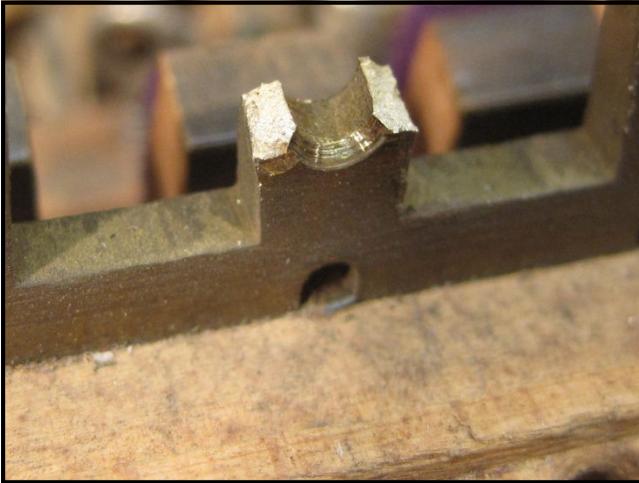
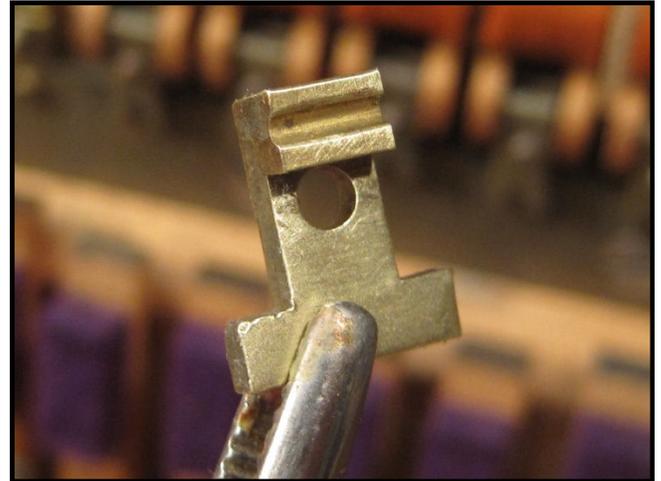
A special brass repair clip is used in this situation which replaces both sides of the channel. It also features a wider base for additional stability, since the original screw hole isn't completely intact.

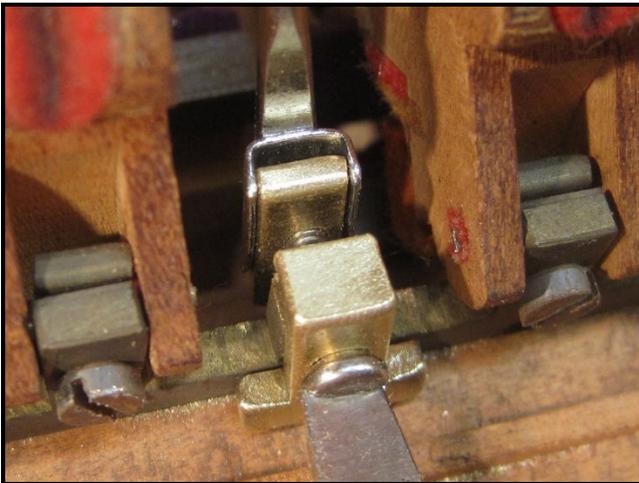
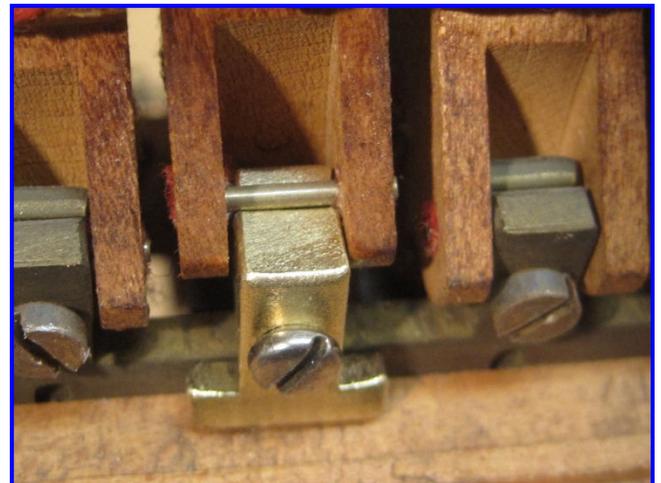
With the clip in place, and the screw inserted, a new butt plate is held in place with an insertion tool.

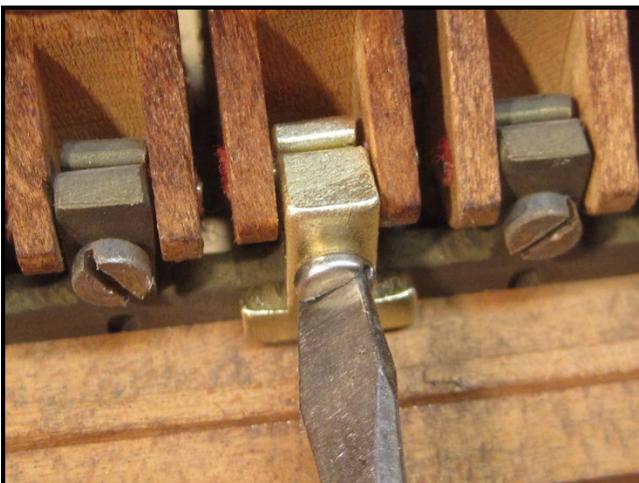
Before the butt plate is drawn down tight, the center pin of the corresponding hammer butt is slipped into place (above photo). Once in place, the plate screw is tightened down. As long as the stub of the tongue is solid, this will be a permanent repair to the action.

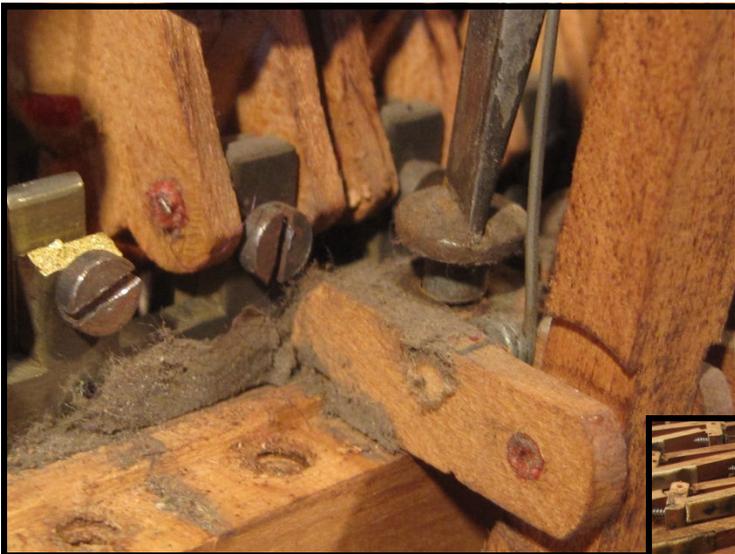
That depends on the severity of the problem. If just one or two butt plates are to be replaced, that can be accomplished by removing the action, doing the replacement on-site, and then reinstalling the action. If a more thorough job is to

be done, it would be better to take the action to the workshop. While the action is on the bench, the dampers (and hammer assemblies if needed) can be removed to facilitate repair work and to allow for a thorough inspection of the entire brass rail / flange system.

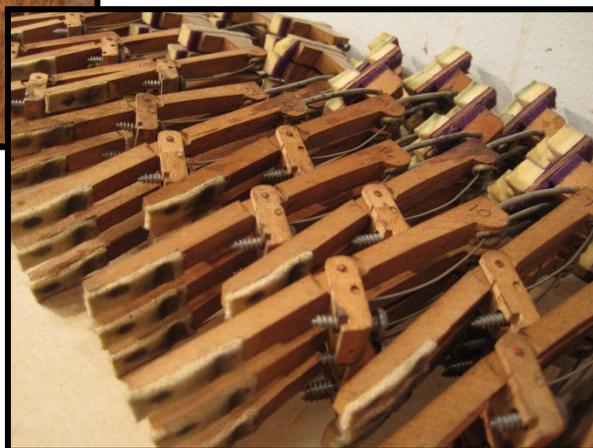
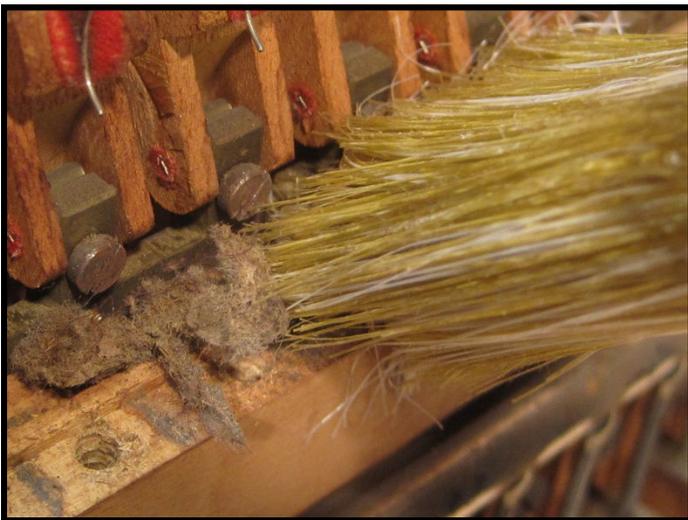
With the adjacent parts out of the way (right photo), and the accumulation of dust removed (below photo) the individual tongues and butt plates may be carefully inspected for hairline cracks.

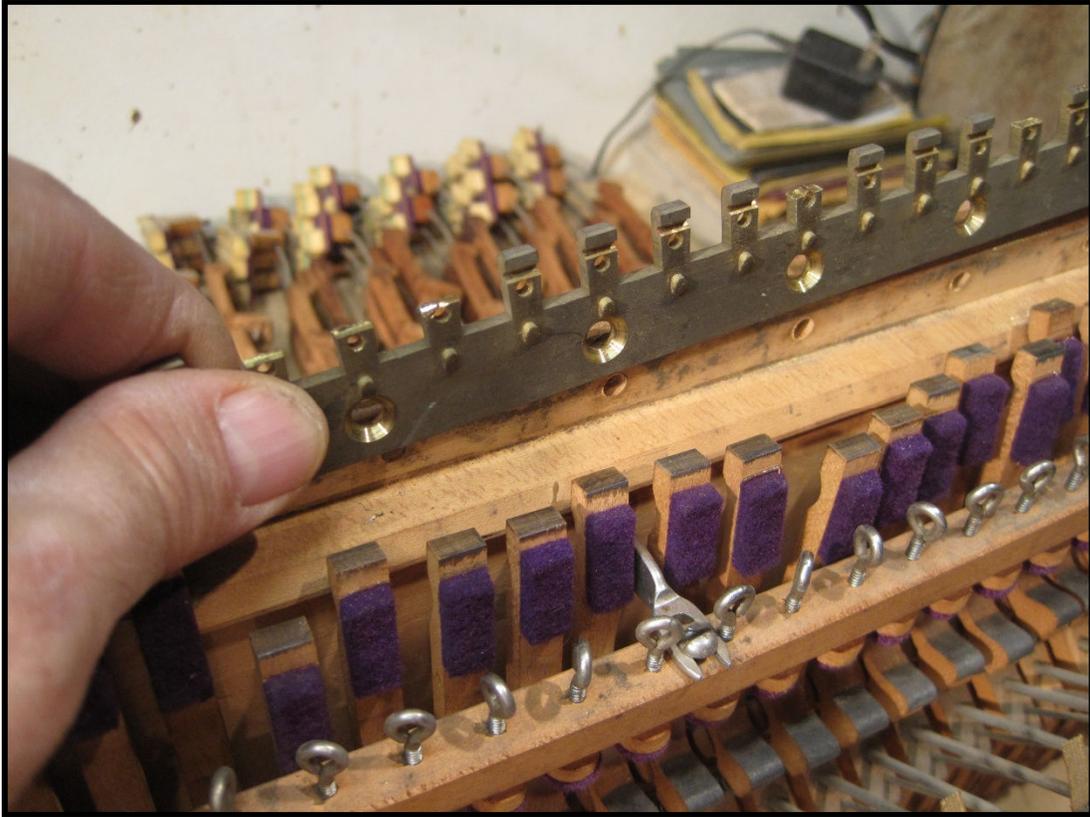
Brass rail with multiple problems being removed for duplication.
