# The Piano Owner's Heads-Up Guide to Important Piano Maintenance

## Focus On: Brass Rail Repair

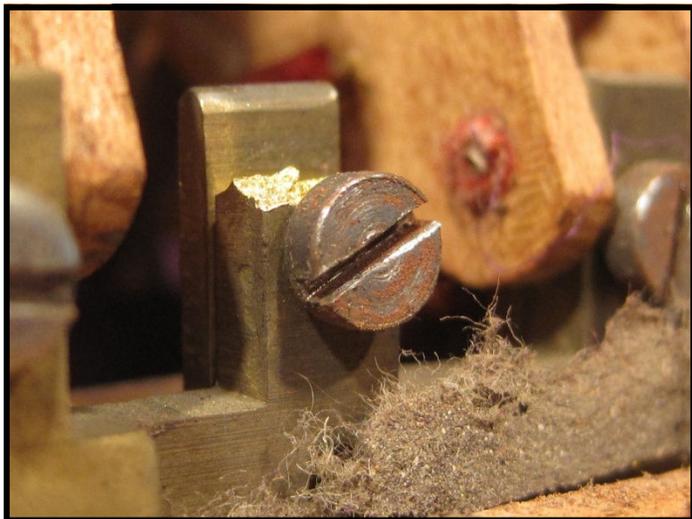
In a piano action with a brass rail each hammer assembly (consisting of a hammer, hammer butt and hammer shank) pivots on a brass center pin held in place between a 'tongue' of the brass rail itself, and a small rectangular brass part called the butt plate. The repairs needed the most often are replacement of broken butt plates, and repair of broken tongues on the brass rail itself. Sometimes when a number of tongues are broken, it makes sense duplicate and replace the entire brass rail.

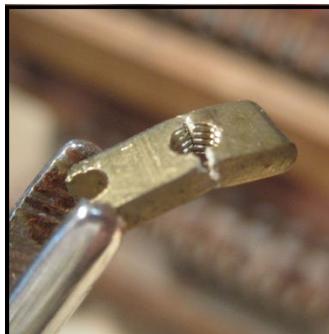
*Broken butt plate*

When a butt plate breaks, the break is nearly always in line with the threaded hole which is intended for a machine screw to affix the butt plate to a tongue of the brass rail.

Individual butt plates may be replaced, but if more than a couple have broken the most practical repair may be to replace the complete set while the action is out of the piano. Once done this problem area will be taken care of for the foreseeable future.

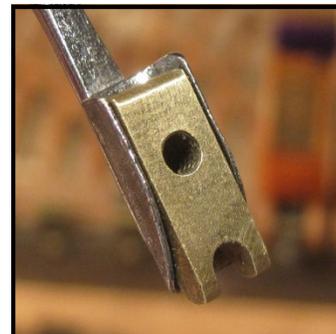
*Replacement butt plate*

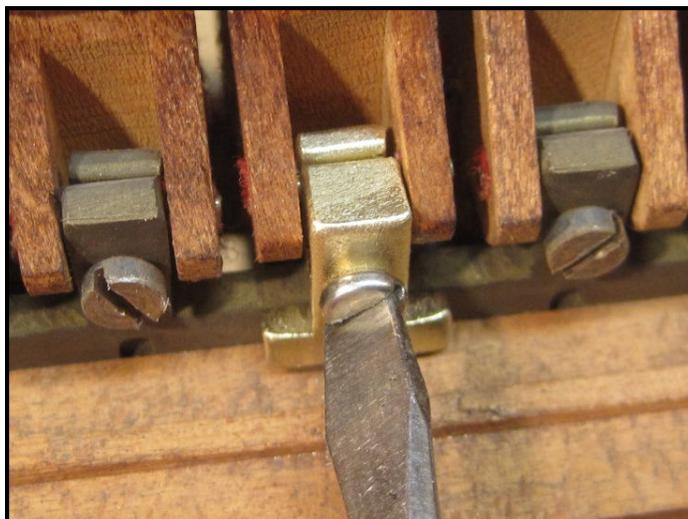
*Repair clip for broken tongue being installed.*

If a tongue of the brass rail has broken, a brass repair clip may be installed (above photo). **Note: If upon inspection the total replacement of the brass rail seems advisable (due to a large number of broken tongues) you will be consulted.**
