The Owner's Guide to Piano Repair

Focus On: Replacing Upright Hammer Butt Springs

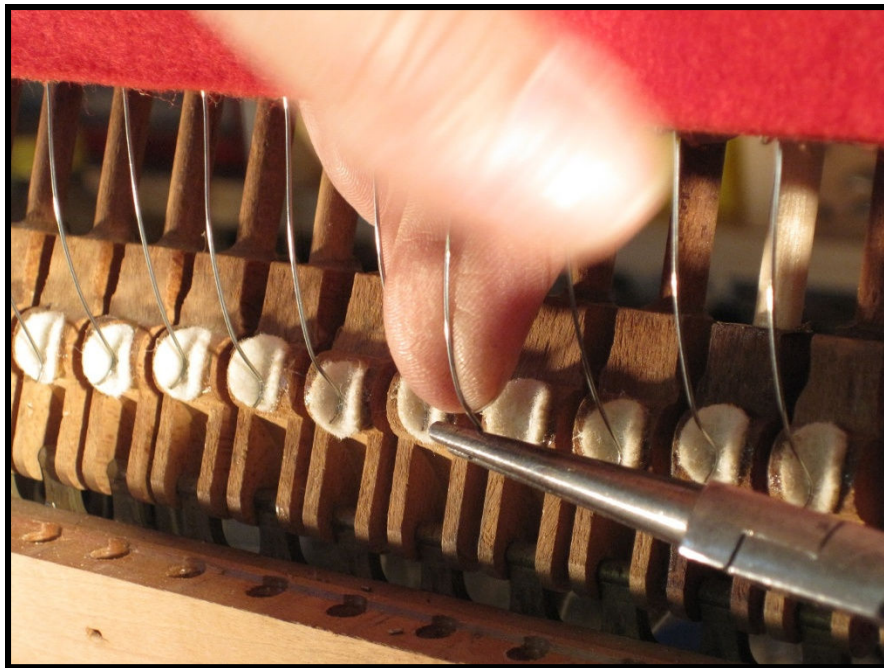
A new set of original-type springs being given final adjustments in the action.

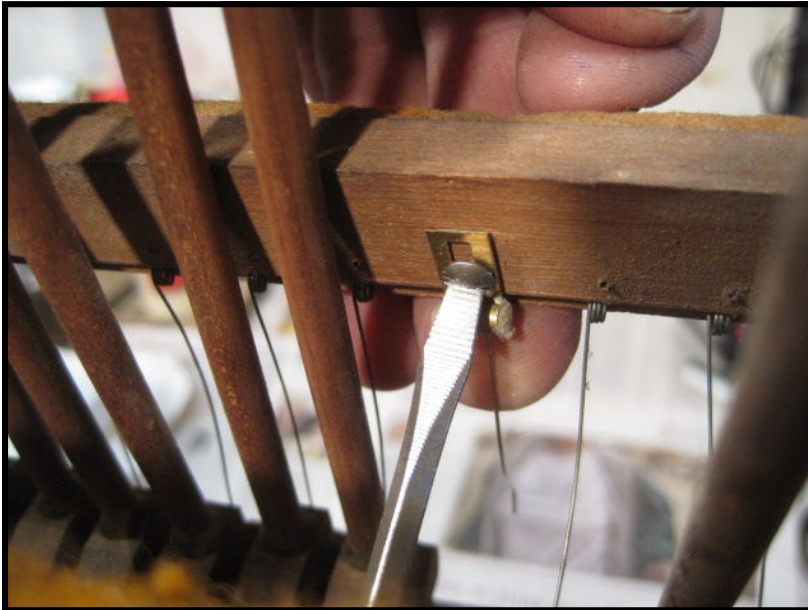
Yes. For an on-the-spot replacement, a hammer butt repair spring may be used to replace a broken spring. The repair spring has a brass clip that may be screwed onto the hammer spring rail, as shown in the photo below.

Although supply catalogues claim this is an easy repair ("Quickly installed in any upright action without removing the spring rail. . ."), it can be a very aggravating job when the small part has to be installed amidst all the other parts. (In the photo, adjacent hammer assemblies and the hammer rest rail have been removed for clarity.)

The screw supplied for the repair clip is tiny, and even when using a special screw-holder, it can be a challenge to get started. Especially when trying to hold the clip in place with one hand, maneuvering the screw around the hammer rest rail and hammer shanks without the screw popping off the screw holder can be an exercise in frustration.

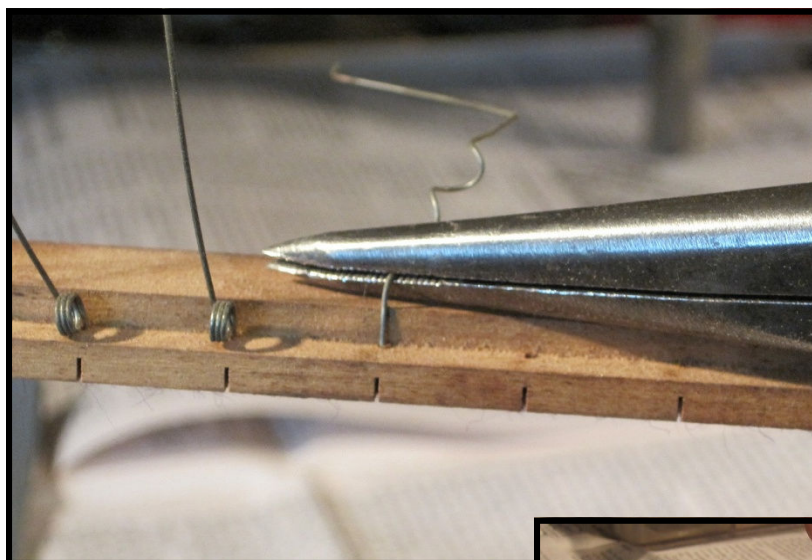
First of all, the hammer butt spring rail is removed from the action. The old springs are then carefully removed by pulling each spring wire free.

The spring rail felt on the back of the rail is scraped off and will be replaced at a later stage in the process.

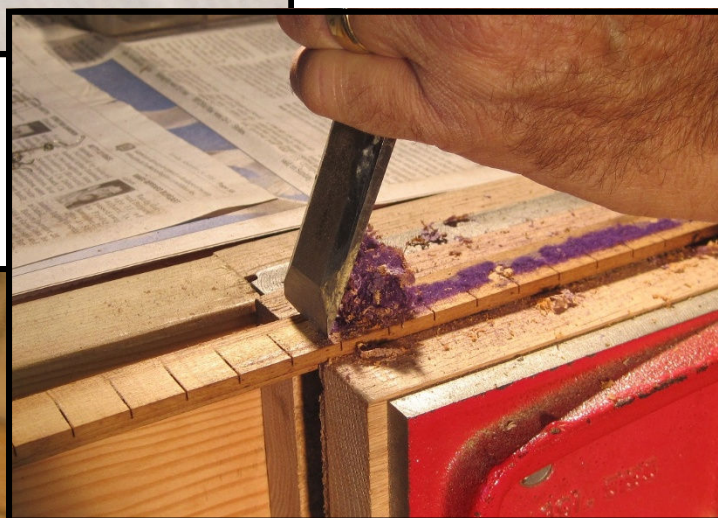
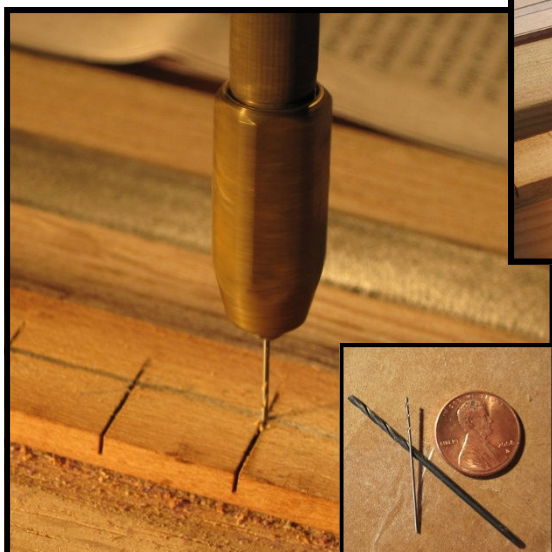
A .025" hole is next drilled in the hammer butt spring rail for the tail of each spring to be inserted through. (The insert shows the size of this drill bit in comparison to a penny, and an ordinary 1/16" bit.)

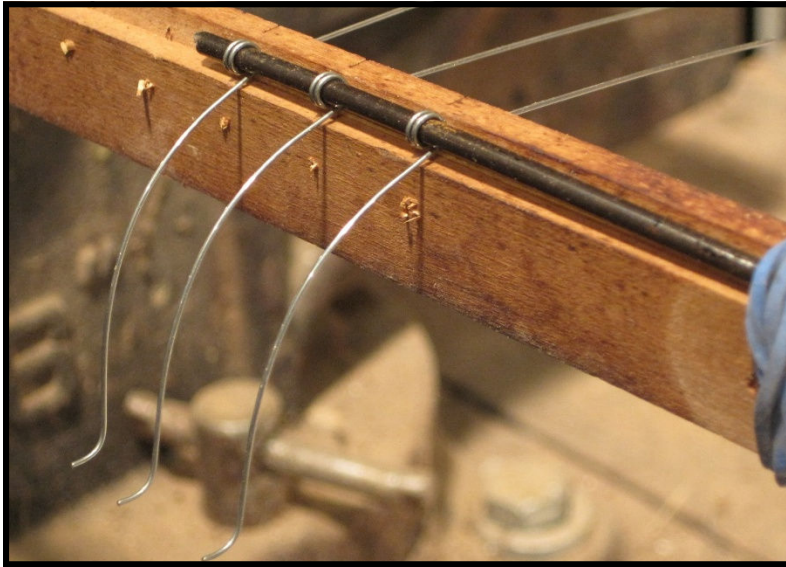
The tail of each new spring is then inserted though the original hole in the rail. (The short sliding wire helps keep the coils of the springs in line while the process is being completed.)

The long tail of each spring is then pulled through the tiny hole which has been drilled. (This step allows the spring metal to be drawn tightly into the slot on the opposite side of the spring rail which the original spring was inserted into at the factory.)

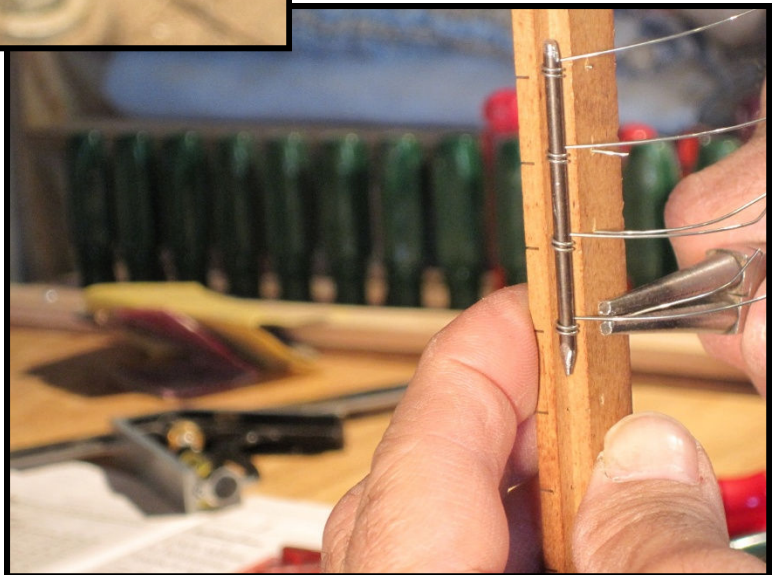
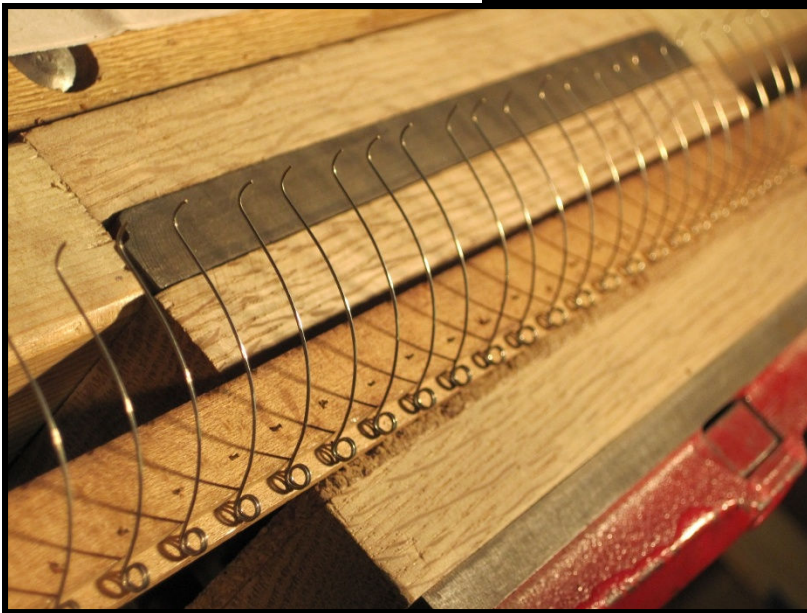
The springs are given fine adjustments while the set is held in place in the vise so that each of the springs lines up perfectly with its neighboring springs. Adjustments from side-to-side, and up and down are required to even out the line.

A new length of fresh spring rail felt is now glued to the back of the hammer spring rail. It is essential that this felt be of the correct width and thickness. This felt is clamped in place in a press overnight to ensure adhesion.

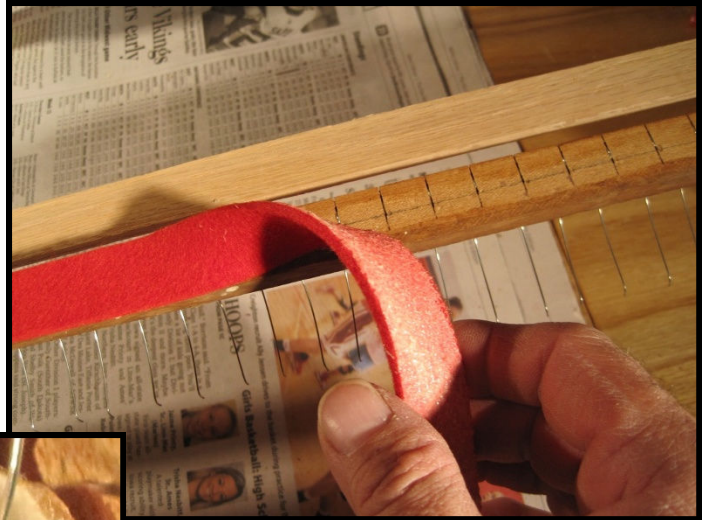
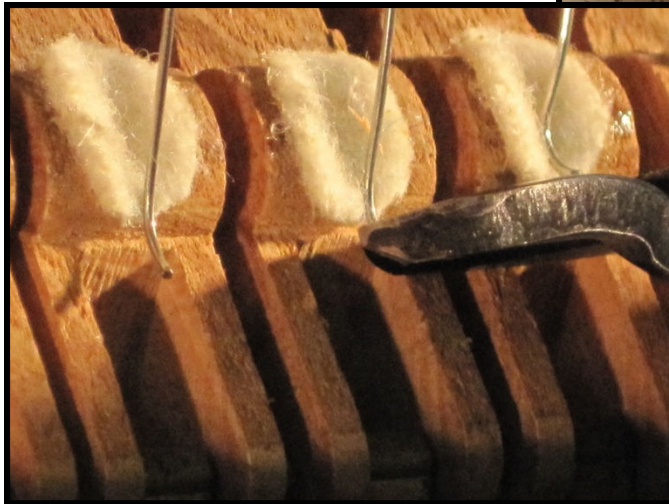
When the new set of hammer springs are reinstalled into the action of the piano, final adjustments are often necessary. Here, springs which are just a bit too long are clipped to the correct length, after which a new curved end is formed.

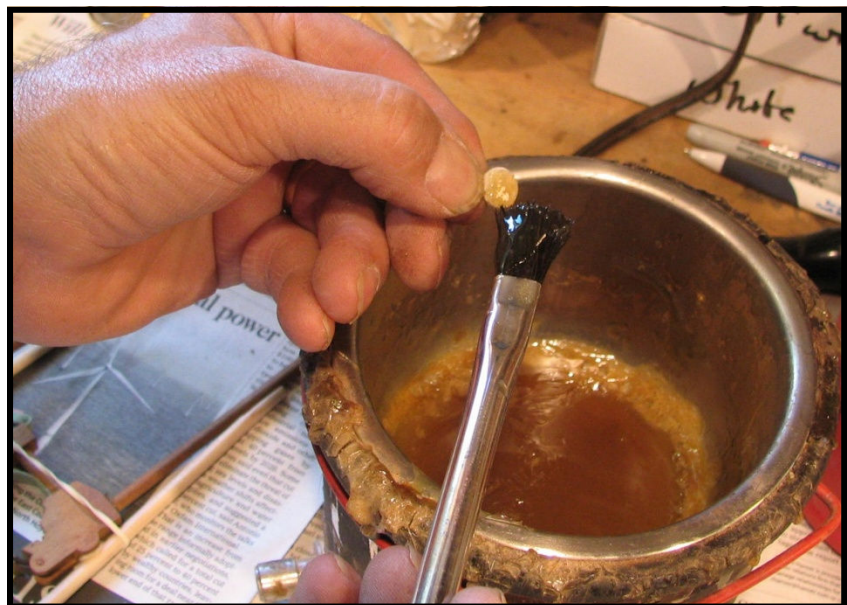
In particular, with a new set of hammer rail springs, it would be highly appropriate to install new felt punchings to line the hammer butt groove that the springs fit into. In the photo, hot hide glue is applied to the back of a felt punching prior to installation.

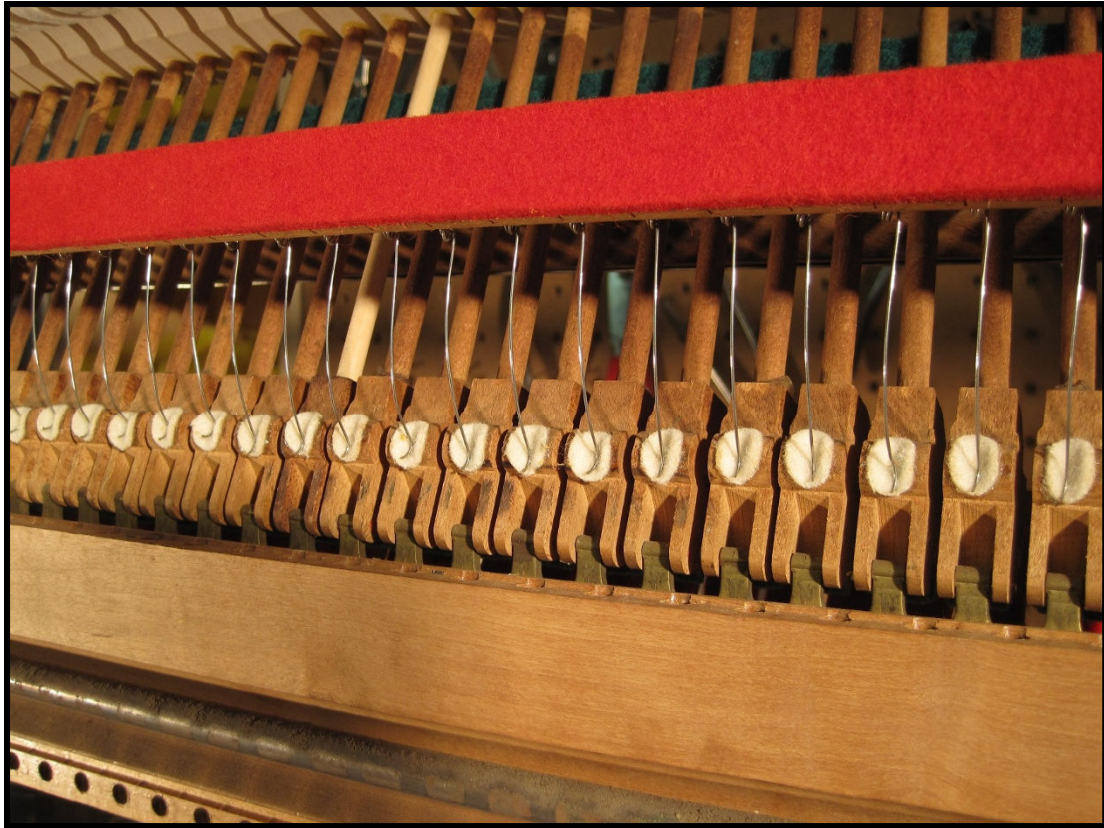
A net set of hammer rail springs helps complete an upright action restoration job.
